CONNECTICUT RIVER BASIN  
SOUTHAMPTON, MASSACHUSETTS

LYMAN MILL POND

MA 00500

PHASE I INSPECTION REPORT  
NATIONAL DAM INSPECTION PROGRAM

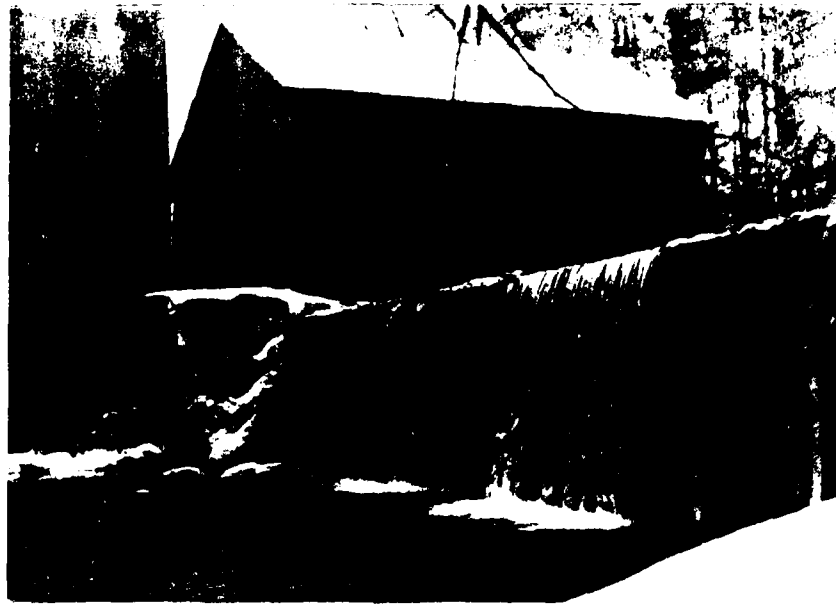
PHOTO NO. 1 - Downstream face of dam from left abutment.

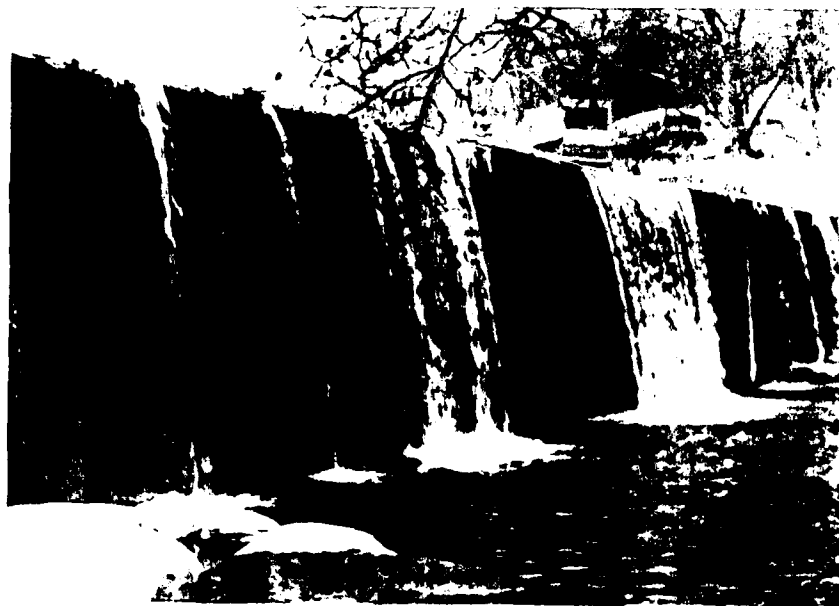
PHOTO NO. 2 - Downstream face of dam from right abutment.

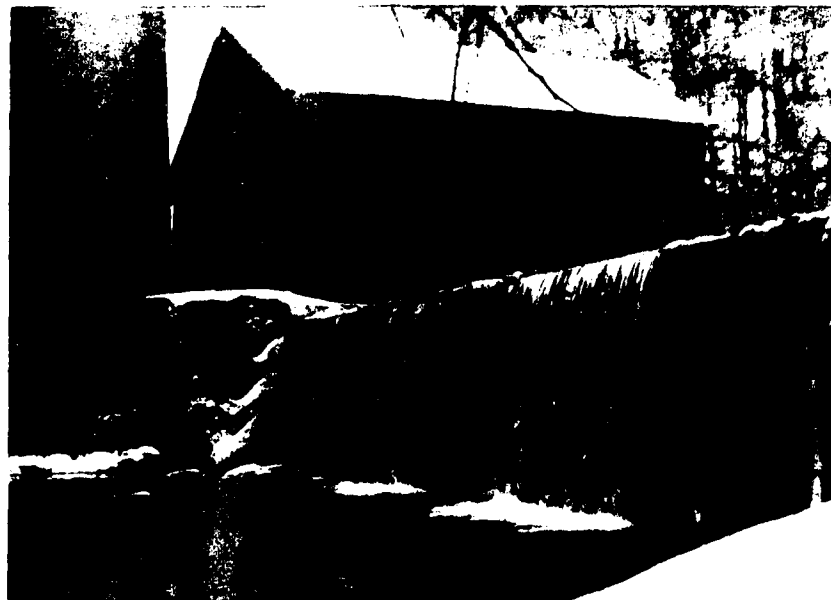
PHOTO NO. 1 - Downstream face of dam from left abutment.

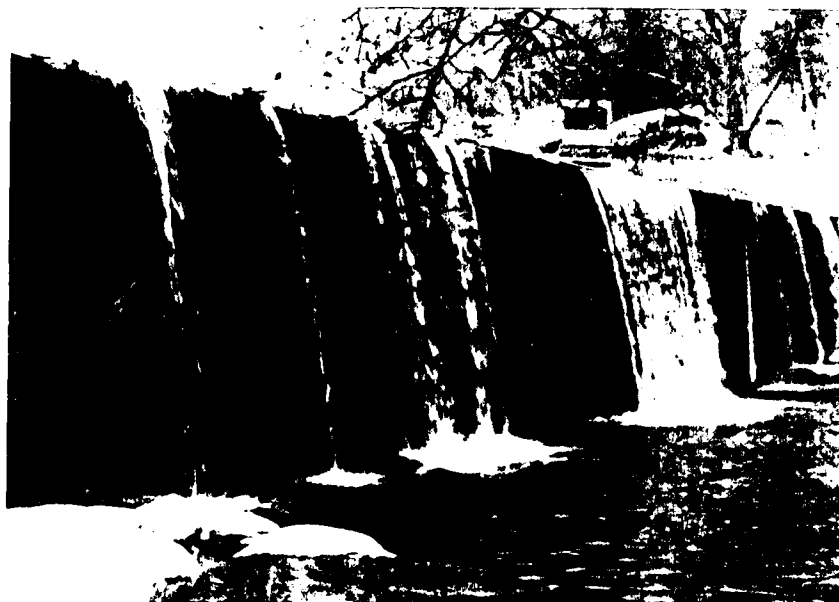
PHOTO NO. 2 - Downstream face of dam from right abutment.
